# WRECK OF THE JAPANESE TYPE 'A' MIDGET SUBMARINE *M24*

## Preliminary Archaeological Survey Report

Bungan Head, Newport, Sydney, Australia

**Heritage Branch**  
NSW Department of Planning  
Underwater Cultural Heritage Program

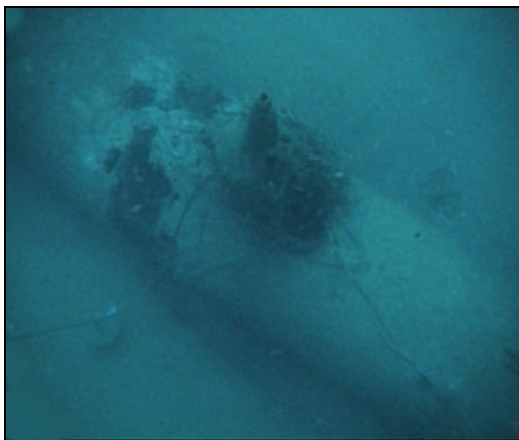
**Figure 1:** General view of the *M24* wreck site. Photo: Heritage Office/Royal Australian Navy. **Figure 2:** The wreck site teeming by fish life. Photo: Heritage Office/Royal Australian Navy.

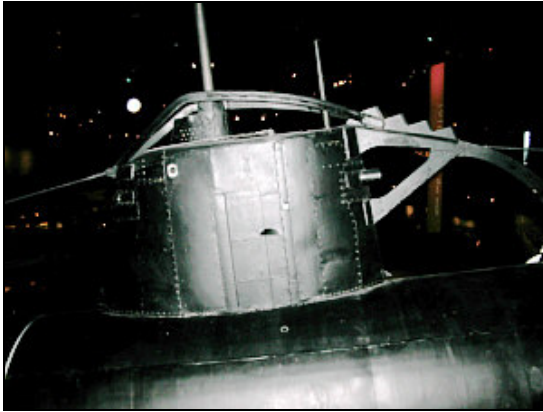
**Figure 4:** The sleek outer lines of a Type A midget conning tower (*Ha-14*).

This vessel, with *Ha-21*, was recovered after the Sydney Harbour raid. Photo: Tim Smith.

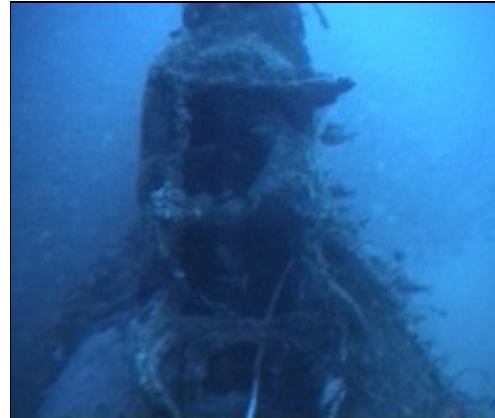
**Figure 5:** *M24* – View of conning tower from forward.

- Significantly, the control room compartment is partly filled with sand to under the original internal casing 'roof'. This sand has apparently entered the space as a result of significant damage to the upper conning tower structure and the aft battery room openings. Externally, all plating that comprised the conning tower has been removed from the hull, including the forward access 'chute' into the control room. This once formed part of the pressure hull and its removal has formed an artificial opening into the main hull atop the submarine. Only the pressure dome and periscope standard of the aft portion of the conning tower survives intact, however, the damage has created an opening of approximately fifty (50) centimetres in diameter.

- Drift sand has probably entered the control room space partly through this opening and apparently to the same depth as observed in the aft battery room. When the finders video footage of the wreck was first examined, there was an indication that the rear bulkhead door into the control room was closed. This led to speculation that both fore and aft doors were probably shut to enable sand accumulation and retention within the control room space. However, the current surveys have confirmed that the aft door to the control room is in fact open, though significantly sanded up. It is likely that the forward control room bulkhead door is closed to assist sand build up. If future examination shows this is not the case, the forward battery room and perhaps the torpedo room, must also have significant introduced sand deposits.

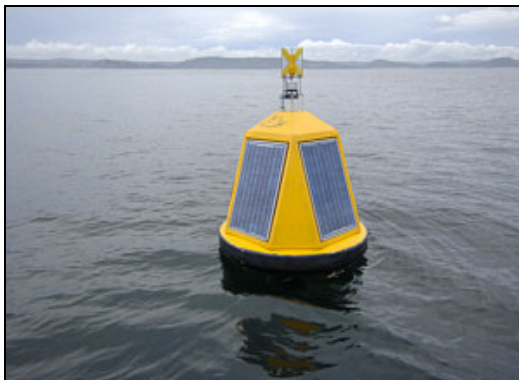
**Figure 6:** Part of the Zylotech Ltd. acoustic and camera surveillance system

Established at the site with real time alert and data capture capability (<http://www.zylotech.com.au/>). Photo: David Nutley.

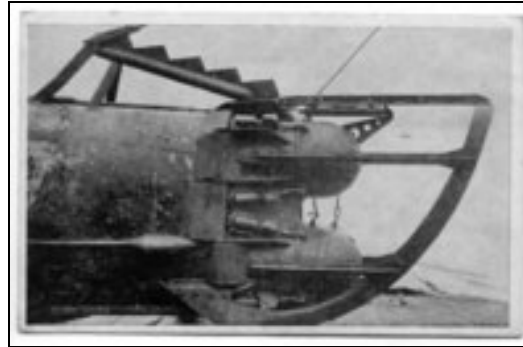
**Figure 10:** Bow of midget *Ha-14*, one of the captured Sydney midgets.

Featured in a series of postcards issued after the May 1942 raid. Courtesy: Denis Gojak Collection.

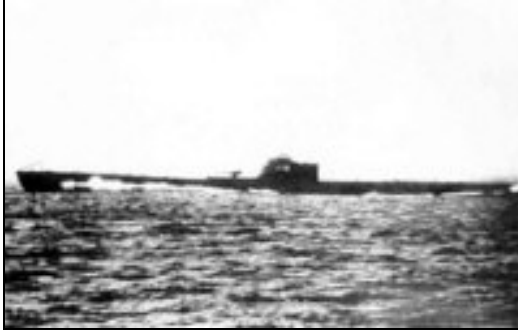
**Figure 11:** Ocean going submarine *I-16*.

Of the class that were fitted to carry midgets, bow facing aft, on their rear deck casings. Image courtesy: Australian War Memorial AWM128899.

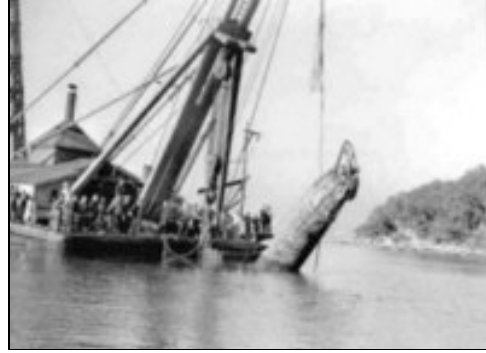
**Figure 12:** Matsuo's midget *Ha-21* being recovered from Taylors Bay.

Image courtesy: Australian War Memorial AWM305088.

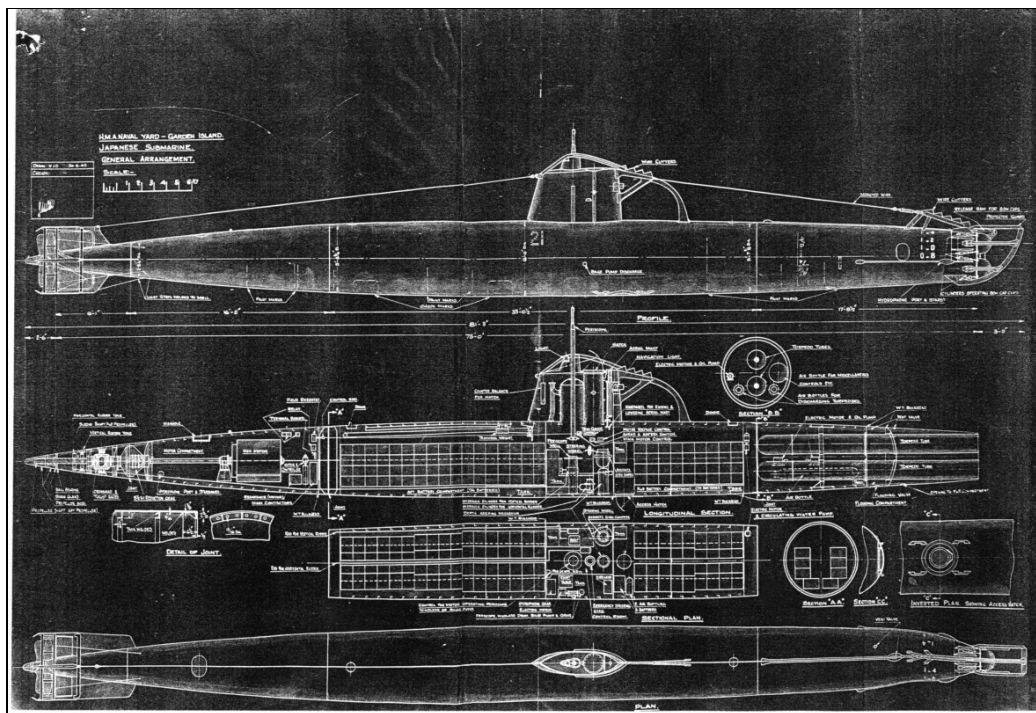
**Figure 13:** Plan of midget *Ha-21* recovered from Taylor's Bay, Sydney, Australia.

The Sydney boats also had an improved gyro compass, an all-weather access hatch on the underside to permit enclosed crew transfers at sea ('traffic sheath'), and a slightly longer periscope at 8-feet (compared to 7-foot) extension above the conning tower <sup>29</sup>. Other fundamental additions included the fitting of improved nose and propeller guards, the distinctive 'net cutters' at bow and atop the conning tower, and external torpedo caps with hydraulic ram releases.

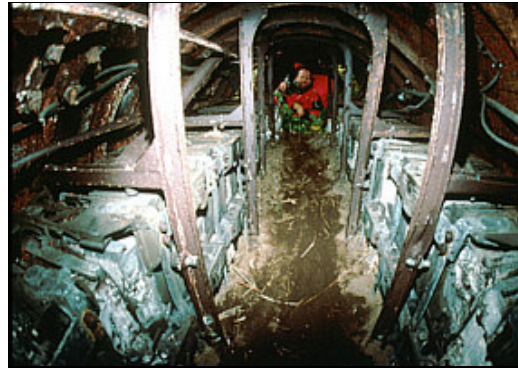
**Figure 15:** Photograph of a midget submarine wreck at Kiska Harbour.

Located in the Aleutian Islands, Alaska, the wreck is unique being in a partly 'dry' state. Photo courtesy: US National Parks Service.

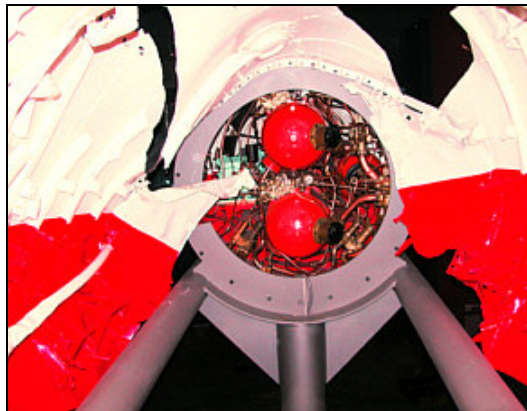
**Figure 17:** Blast damage to Chuman's midget *Ha-14*.

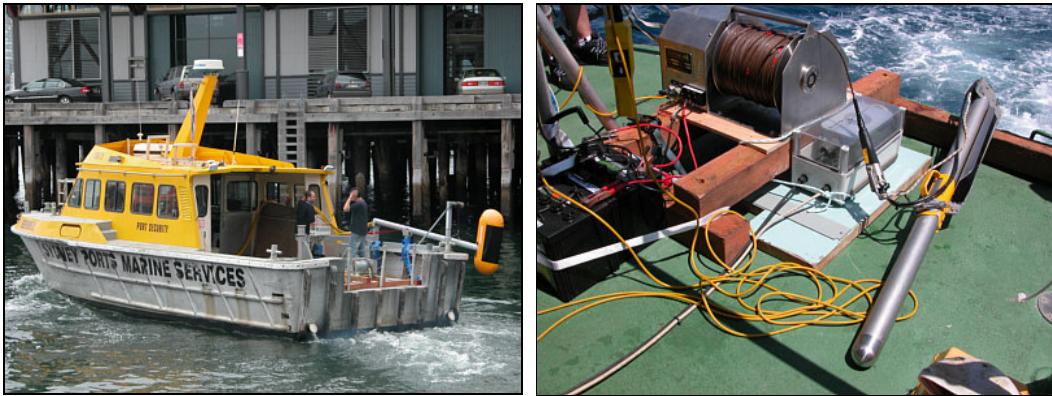
**Figure 20:** Sonartech Atlas Pty Ltd. sonar survey.

The sonar imaging and preliminary 3-dimensional seabed mapping using Sonartech Atlas's experimental *Fansweep* multibeam sonar (results not available for this report), indicated that the submarine lies in an east-westerly direction, with the bow pointed towards the open ocean (east).

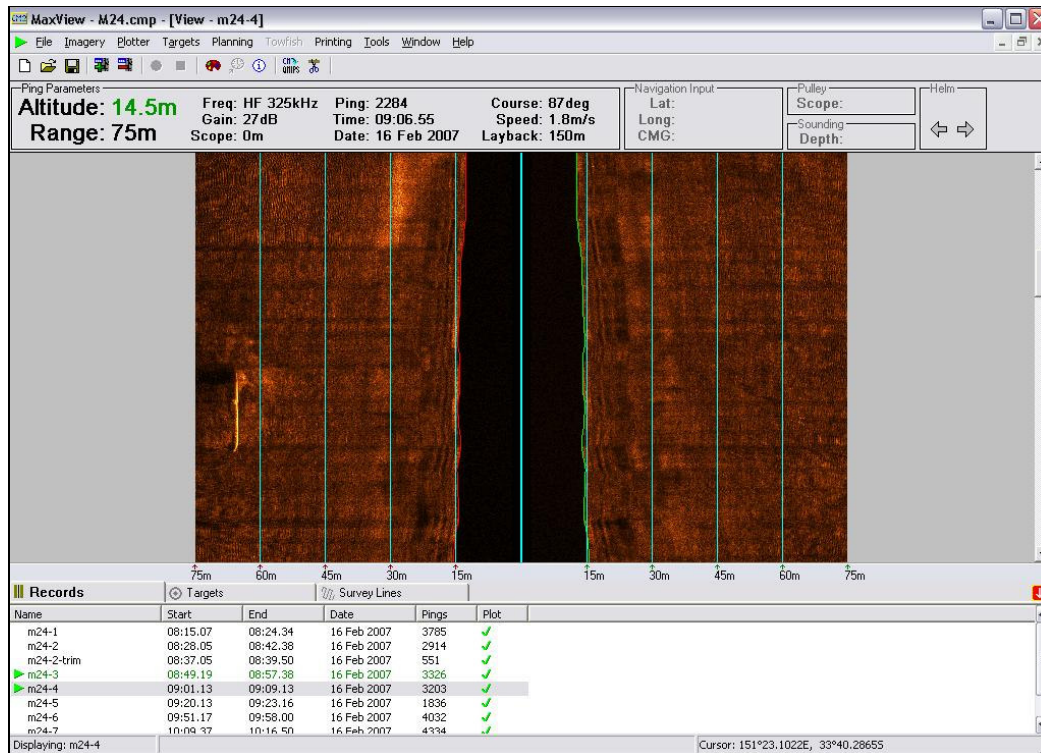
**Figure 21:** Sonartech Atlas Pty Ltd. survey.

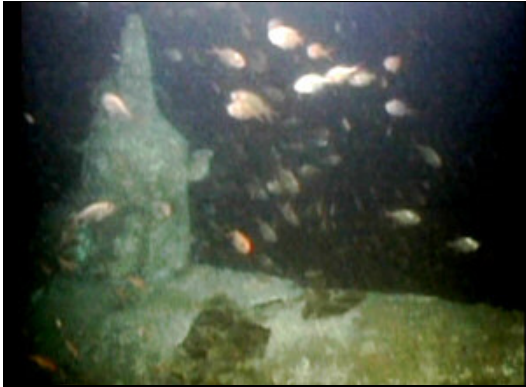
**Figure 22:** View aft of the conning tower on the port side.

Supplementary imagery obtained during the *Curv* remote operated vehicle survey. Photograph: Defence Maritime Services/US Navy.

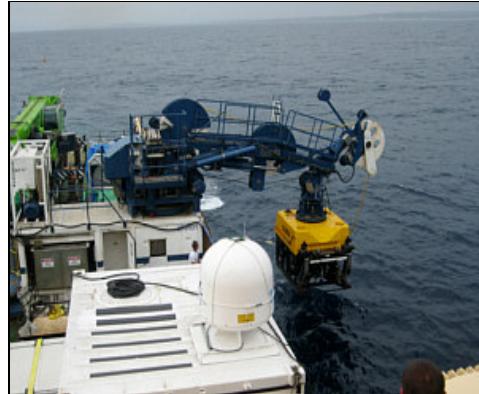
**Figure 23:** ROV *Curv*.

The vehicle was deployed above the midget submarine on 22 February 2007. Photograph: David Nutley.

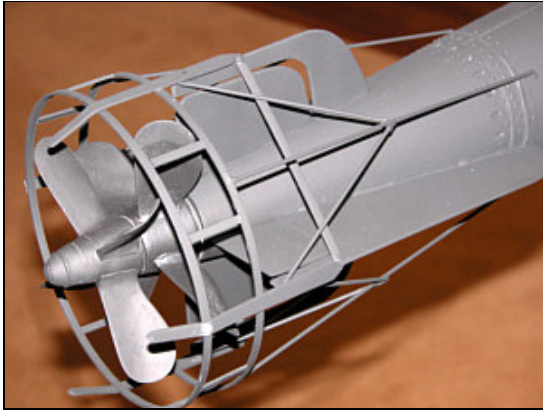
**Figure 26:** Detail of original Type A midget stern arrangement.

The model indicates how much of *M24*'s tail structure has been removed by fishing nets, or still lies buried. Photo: Tim Smith. Model courtesy: Animax Films Pty.Ltd.

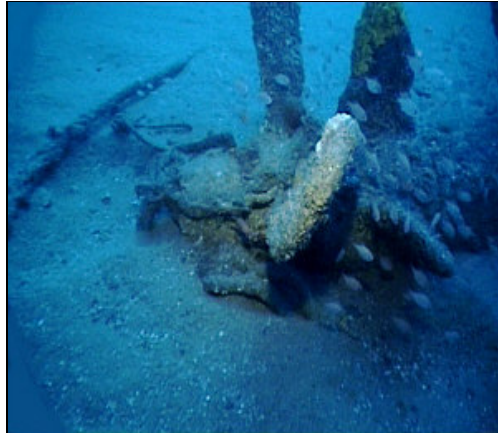
**Figure 27:** *M24*'s propellers.

- At the stern, sand levels lie at the centreline of the propeller boss (missing). Both contra-rotating propellers are visible, although all exposed rudders, stabilisers and the protective cage around the propellers have been removed by fishing nets. Just forward of the stern, the topside manhole that gave access to the motor room appears lost to corrosion, providing a minor cavity in the hull plating.

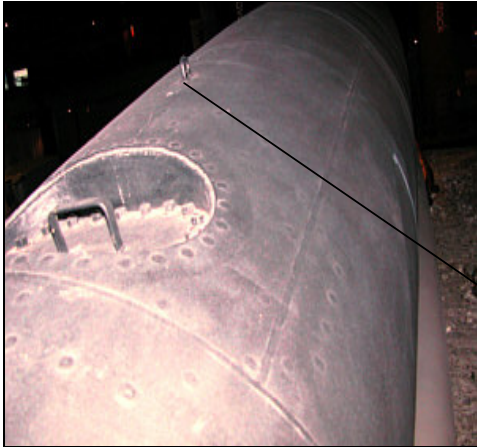
**Figure 28:** Aft man hole cover on the stern section of midget *Ha-14*.

As displayed at the Australian War Memorial, Canberra. Photo: Tim Smith.

This image shows additional corrosion damage in the surrounding casing. The circular hole (at left of picture) appears to correspond to the external lug position on *Ha-14*'s stern (Figure 28). Photo: Heritage Office/Royal Australian Navy.

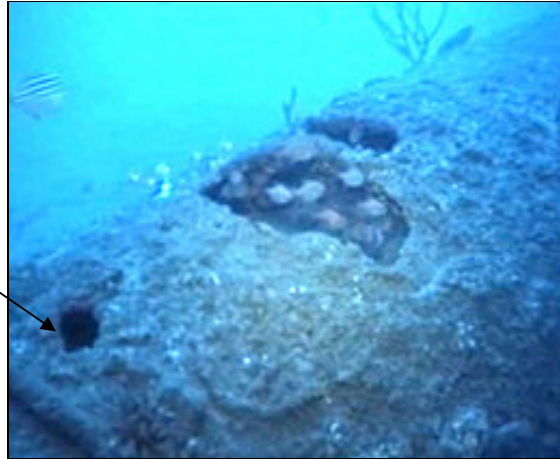
**Figure 29:** Detail of manhole on *M24* wreck.

The motor room is intact and will contain the 1.5-tonne 600 horsepower electric motor. Moving forward along the upper casing, the aft manhole that once gave limited service access into the motor room appears as a corroded opening. It is unclear whether this damage has been caused by past fouling of nets or reflects general corrosion activity around its semi-recessed form. Isolated corrosion holes in the roof line are found immediately forward of the manhole and it appears that the motor room is totally filled with sand.

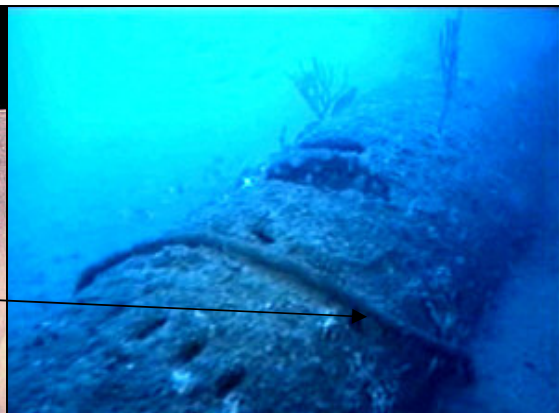
**Figure 31:** Detail of fishing net line wrapped around the *M24* hull at aft tail section. Photo: Heritage Office/Royal Australian Navy.

Of special interest is a rope that has snagged the wreck at an earlier time, 'corkscrewing' around the hull completely in two turns. The turns lie either side of the manhole area and disappear into the sand. It is clear that this rope, possibly a lead line from a fishing trawling net, could only have wrapped around the hull if the midget's stern was once proud of the sand at this point. Later settling of the wreck or build up of surrounding sand deposits has now 'trapped' the rope.

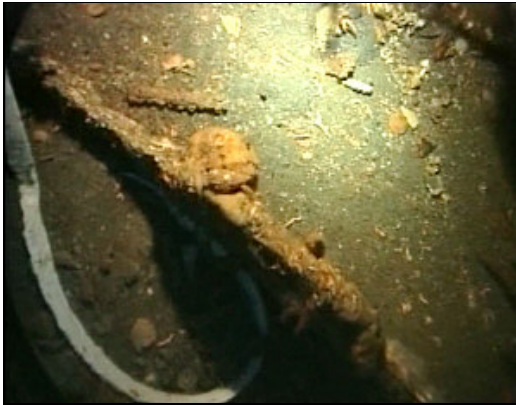
**Figure 33:** Vertical view inside aft battery room. The image shows a largely buried structure that appears to be the top of the curved hinged door separating the control room. Photo: Heritage Office/Royal Australian Navy.

the aft battery room openings indicates that the aft bulkhead door to the control room is open, and what appears to be the door swung open to starboard. Closer investigation suggests that the sand level observed in the aft battery room continues into the control room space itself, with no obstruction. Some remnant fishing nets are visible inside the control room but likely carried in by swell action. It is unknown whether the forward door is closed or open as no detailed inspection has yet been made of the forward bulkhead. If open, similar sand levels may have penetrated the entire forward end of the submarine.

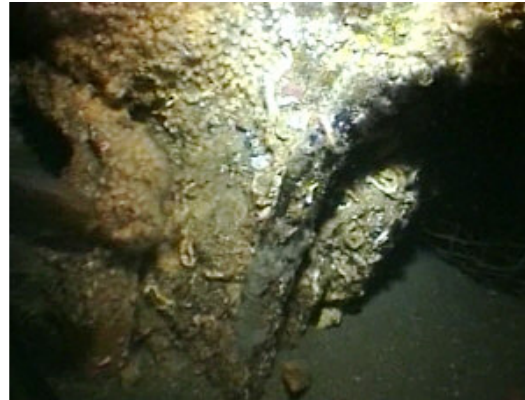
**Figure 34:** The port-side coaming of the doorway. The view is through the main bulkhead looking from the aft battery room into the control room. Note continuation of introduced sediment levels. Photo: Heritage Office/Royal Australian Navy.

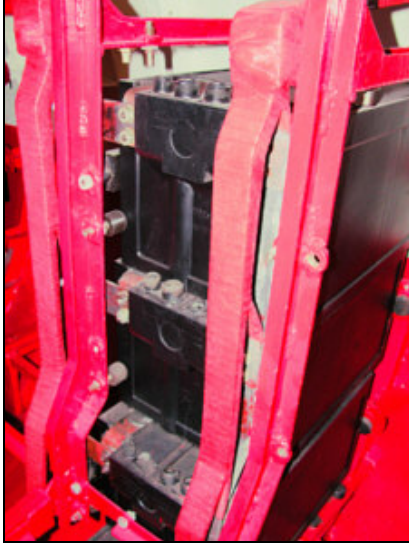
**Figure 35:** Preserved battery stack in the aft battery room of midget *Ha-14*.

Aft battery room of *Ha-14* on display at the Australian War Memorial. This stack lies in a similar position to the batteries observed through the hull openings immediately aft of the control room on *M24*. Note that the bottom battery in the stack is out of photo at floor level. Photo: Tim Smith.

When entering the aft battery room through the main starboard opening, the flat tops of batteries are immediately recognisable. Neatly stacked in their original racks ('trays') behind the starboard wall of the hull, only one row of batteries is visible. The batteries were stacked four high atop each other in the linked racks. As the outside hull is buried approximately 50% amidships, it is apparent that the top row of battery stacks are on show. This is supported by examining the cross-sectional drawings of the aft battery room in the archival drawings of *Ha-21* (figure 60).

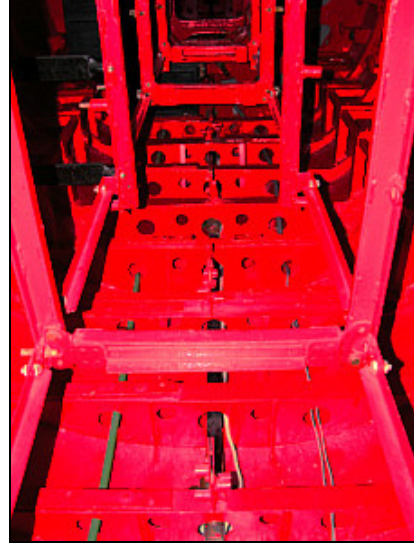
**Figure 36:** View aft within aft battery room, *Ha-14*.

This image shows the floor frame levels which would have been covered by an original removable floor. These features lie buried under sand within *M24*. Photo: Tim Smith.

The central passageway between the port and starboard battery stacks is therefore sanded over to the extent that none of the floor frames or lower batteries levels are visible. Based on the level of external and internal deposits this suggests that a depth of some four-feet or 1.2 metres of sand has entered the compartment.

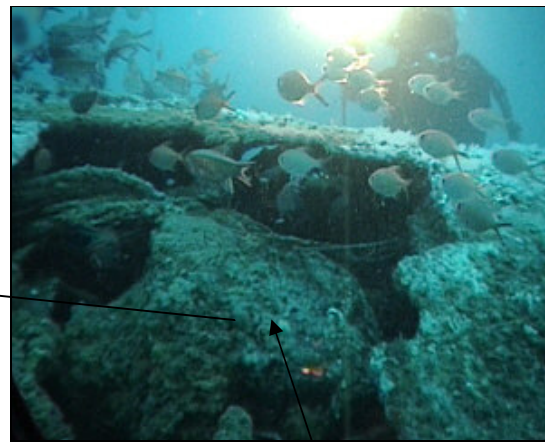
**Figure 38:** View into corrosion opening on port side of aft battery room.

8. A significant amount of corrosion has occurred to the main pressure hull immediately aft of the control room (conning tower), enabling access points into the main hull at the aft battery room.

9. The cause of this damage is presently unconfirmed, but most likely resulted from stress applied to the hull at this point during the attempted recovery of entrapped fishing nets.

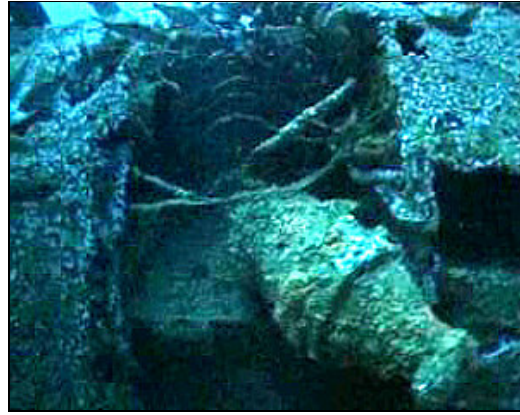
**Figure 40:** Detail of object in aft battery room.

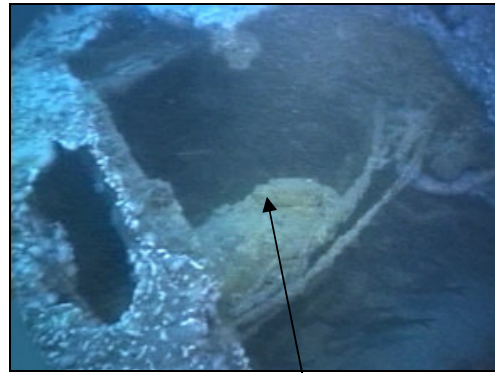
**Figure 42:** Heater Unit in situ.

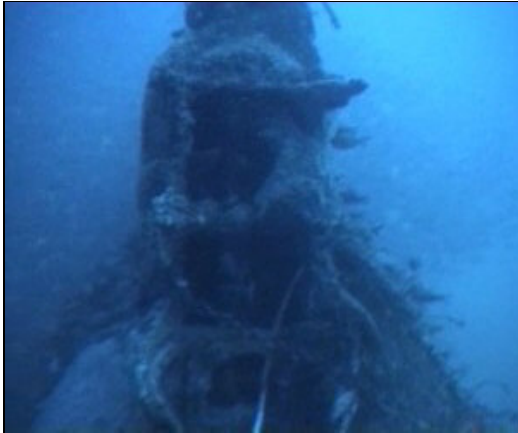
**Figure 43:** Remains of *M24*'s conning tower. View from bow, aft. Note the access chute removed, and steps built into the junction with the periscope well behind.

6. These impacts (of unknown number and frequency), have most probably caused the observed removal of most of the conning tower structure, bow and conning tower net cutting equipment, torpedo and propeller protective cages, and the forward section of the upper torpedo tube.

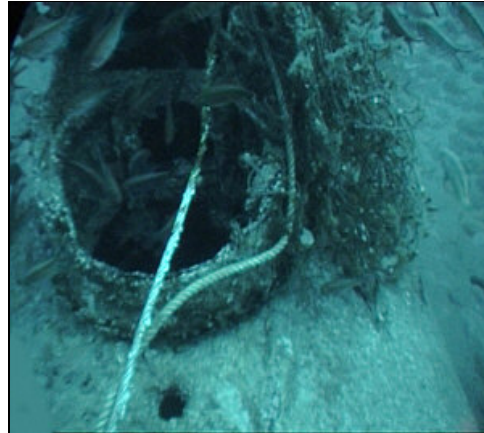
**Figure 44:** Detail of the opening into the pressure hull at the control room.

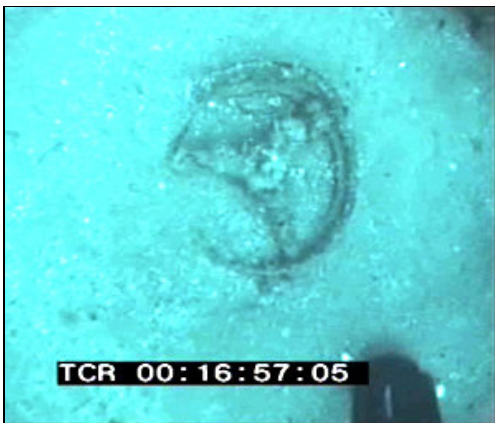
**Figure 45:** Conning tower access hatch. The hatch is sitting on the seabed forward of the conning tower, on port side. View of internal locking mechanism which appears to be in the locked position. The central wheel operating the three lugs is missing.

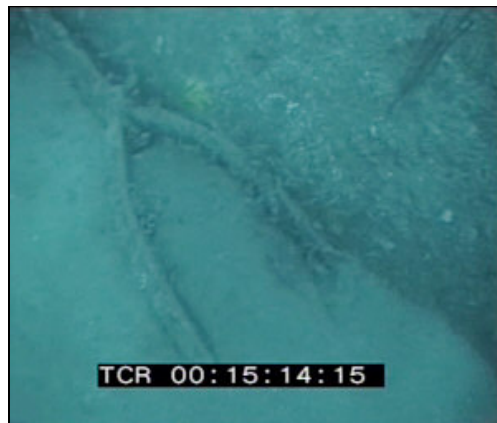
**Figure 46:** The conning tower net cutter. This 4-tooth cutter that once attached to the conning tower is lying against the hull on the port side, aft of conning tower remains. Photo: Heritage Office/Royal Australian Navy.

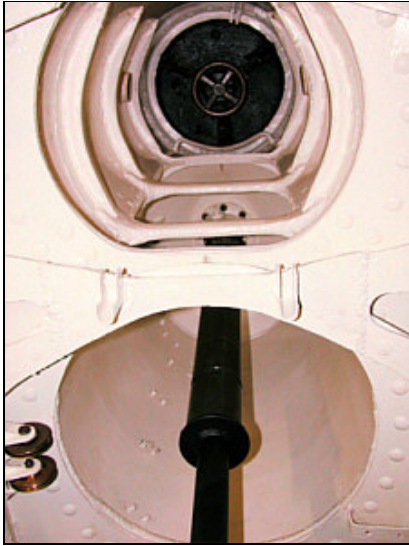
**Figure 47:** Inside Chuman's conning tower from midget *Ha-14*.

Note access chute and hatch (top of picture), and inside of periscope well. These two elements formed part of the pressure hull and a cavity above the 'roof' of the control room. Note that the retractable crew ladder (opposite) has been removed from this AWM display. Photo: Tim Smith.

- Around the internal upper 'walls' of the control room are several gauges and levers that comprise part of the operating controls of the submarine. Of particular interest are the 'steps' built into the forward face of the periscope well that allowed crew egress and ingress, and the clearly visible retractable two-step crew ladder hinged at the weld join of the periscope dome and the 'ceiling' of the pressure hull.

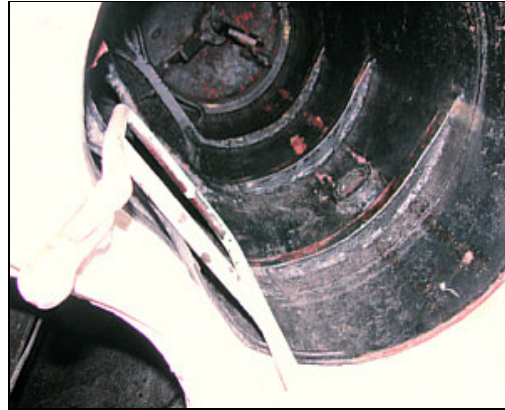
**Figure 48:** Inside Matsuo's conning tower from midget *Ha-21*.

Note the retractable crew ladder in stowed 'up' position, replicating the state of *M24*'s exit ladder observed at the wreck site. Photo: Tim Smith.

- This ladder is still in its upright or 'stowed' position, once within the cavity of the 1.5 metre-deep access chute, now lost. This is the firmest indication that the crew of *M24* are most probably still within the submarine hull. To exit the craft, Ban and Ashibe would have had to pull down this hinged ladder to climb up and out of the control room.
- The original 'signature' of the external conning tower plating is clearly visible on the upper surfaces of the wreck, marked by the angle iron framework where it was attached to the casing.

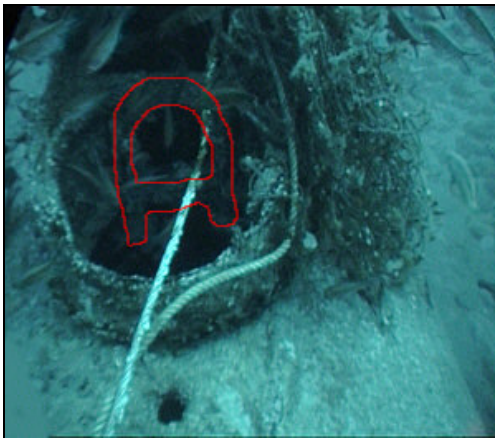
**Figure 49:** Outlined in red is the access ladder in its upright position.

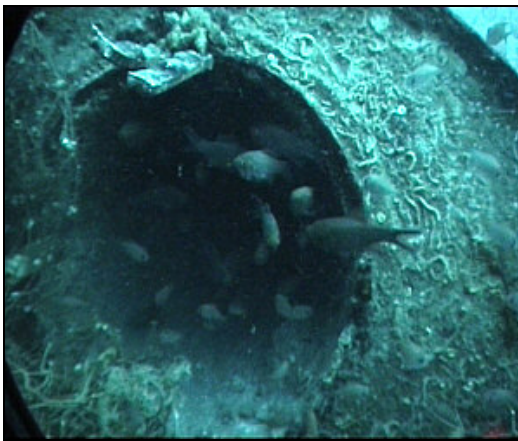
**Figure 51:** Detail of damage to the upper torpedo tube.

Like the conning tower, the forward bow area has witnessed significant physical damage. As noted, the upper of two torpedo tubes has been almost half torn off the hull and now

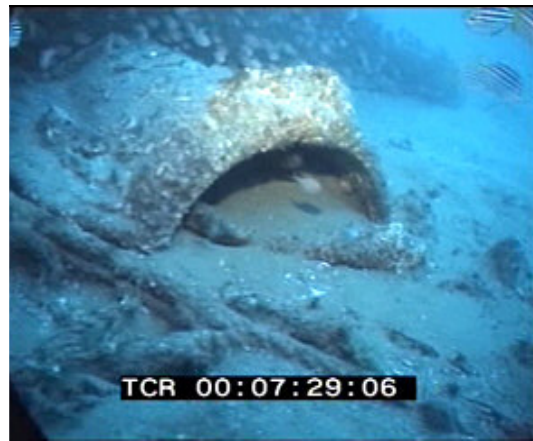
**Figure 52:** Detail of forward face of upper torpedo tube.

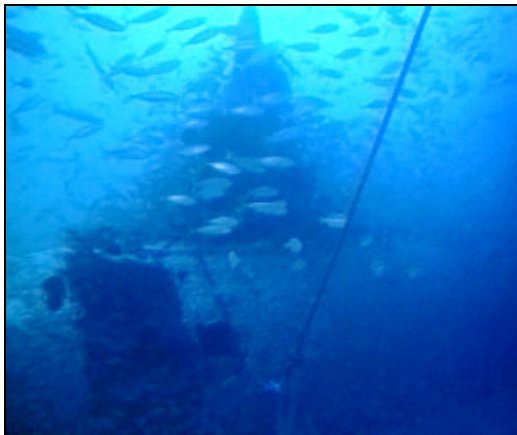
**Figure 53:** Opening in starboard hull.

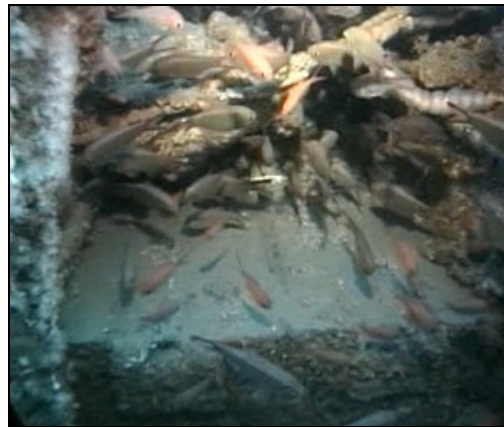
**Figure 54:** Detail of battery.

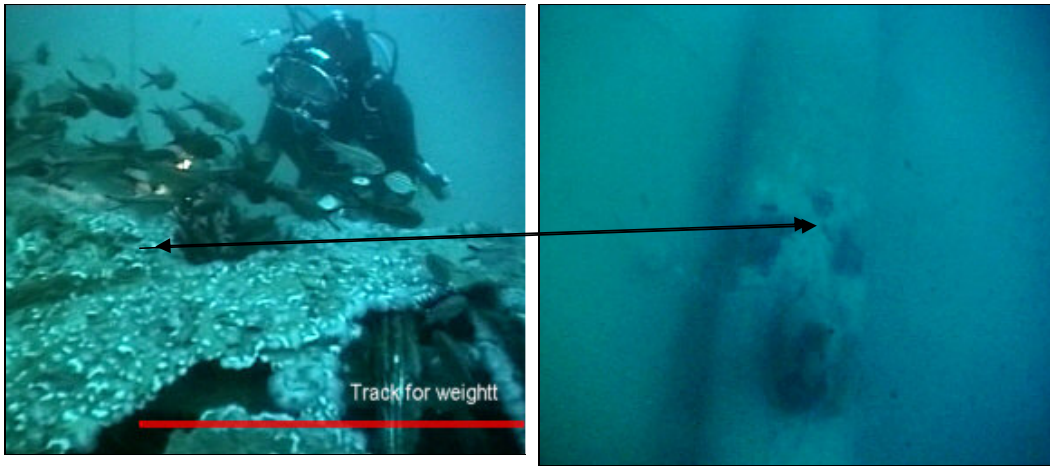
**Figure 58:** Detail of corrosion opening on port hull, aft.
